## **Environmental Audit Summary**

**Cherokee Brooks Street Vallejo  
(Former General Mills Facility)  
Vallejo, California  
October 27, 2008**

Reference: Environmental Audit Summary Report  
Cherokee Brooks Street Vallejo  
Duncklee & Dunham Project No. 200815F

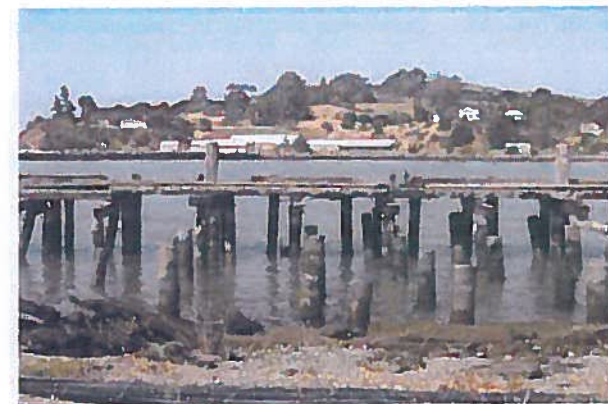
**Photo 8**

**Remains of the docks from the Starr Mill that operated at the Site from 1869-1895.**

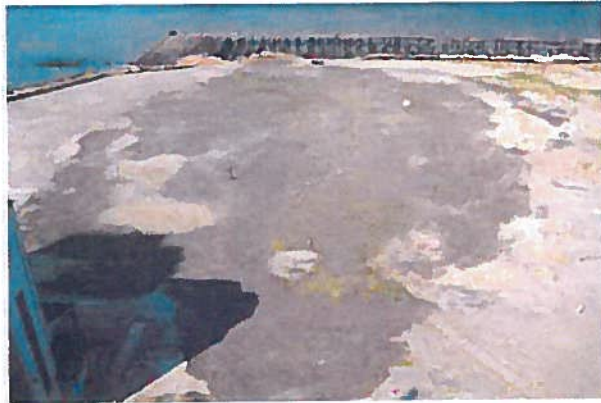
**Photo 9**

A relatively large area of petroleum hydrocarbon-impacted soil was identified in 2005-2006 on the Leasehold property at the western area of the Site (see Figure 1). While the specific source(s) of this contamination have not been confirmed, the impacted area appears to be associated with several former USTs and a part of the Site that was previously used to dispose of debris and other fill materials. The petroleum hydrocarbons consist primarily of diesel fuel and motor oil. Various polynuclear aromatic hydrocarbons (PAHs) also have been detected in the same general areas as the petroleum hydrocarbons. General Mills remediated this area by excavation, in accordance with a work plan approved by SCDRM to meet the Site-specific approved cleanup goals for commercial/industrial use in the Leasehold parcel (see Photo 9). Further information on the status of this work is provided in Section 1.6 of this report.

View of the area of former petroleum-contaminated soil, excavated by General Mills on the Leasehold. This area depicted in gray on Figure 1.

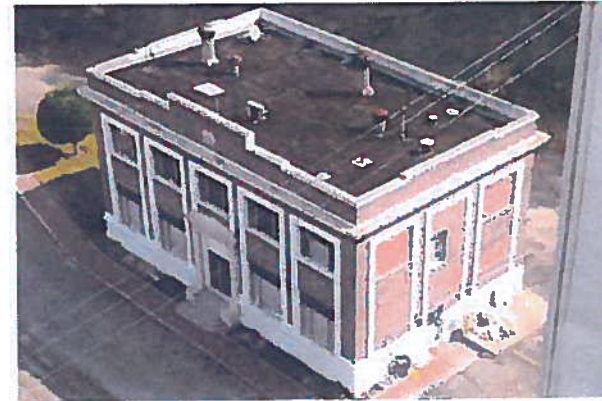
**Photo 10**

- 2.3** There are a few key environmental documents that Malcolm Pirnie produced missing from Cherokee intranet site for this asset.
- 2.4** The Environmental Management Plan is dated August 7, 2008 and does not reflect current conditions. However, it appears that General Mills has conducted the environmental work on schedule. Other than asbestos abatement, the environmental budget is geared towards contingencies that to date are not yet needed so the environmental portion of the project is well within budget. Asbestos abatement was performed on the General Mills office building that was renovated for Brooks Street's offices, but further asbestos abatement won't be conducted until entitlements are obtained.

View of the historic office building from the top of the mill. Asbestos removal had been completed by the time of the Site visit. Brooks Street will move their offices to this location after renovations are complete.

Brooks Streets offices will be moved into the renovated office building (see Photo 10) on the Site. Having their presence on the Site will undoubtedly prove to be useful during the CEQA process and any due diligence periods by prospective redevelopers of the Site.

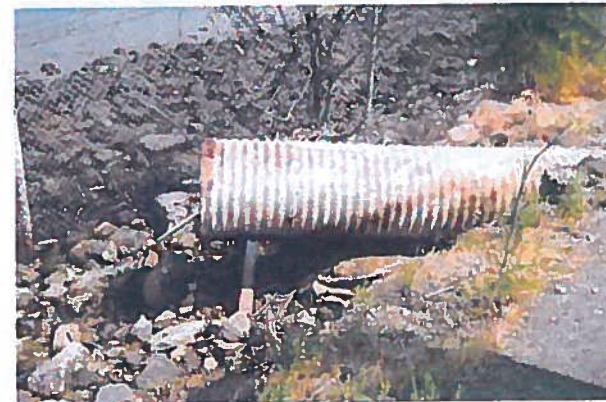
**Photo 12**

Stormwater collected from drains and catch basins around the Site discharge directly to the strait.
